Residual properties of three-span continuous reinforced concrete slabs subjected to different compartment fires

Wang, Y, Chen, Z, Jiang, Y, Huang, Z, Zhang, Y, Huang, Y, Li, L, Wu, J & Guo, W 2020, 'Residual properties of three-span continuous reinforced concrete slabs subjected to different compartment fires', *Engineering Structures*. <https://doi.org/10.1016/j.engstruct.2020.110352>

Engineering Structures

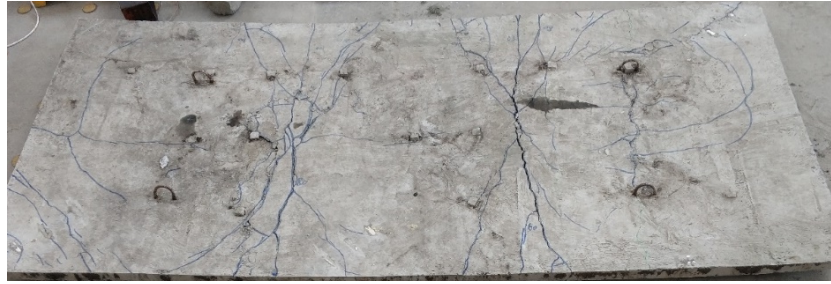
Fig.5. Failure modes of Slab S0. (a) Cracks on the top surface;(b) Cracking pattern on the top surface;(c) Cracks on the bottom surface;(d) Cracking pattern on the bottom surface.

For the reference Slab S0, as shown in Figs. 5(a)–5(d), the flexural failure mode appeared with a larger crack intensity because the punching shear strength of the reference slab was higher than the bending

moment capacity. In addition, as discussed later, the maximum concrete strains on the top surface of the most spans were lower than 3300×10^{-6} [37], and thus the concrete crushing on the corner of each slab did not occur during the test. Finally, for the reference slab, its failure was determined by the hogging flexural strength near two interior supports.

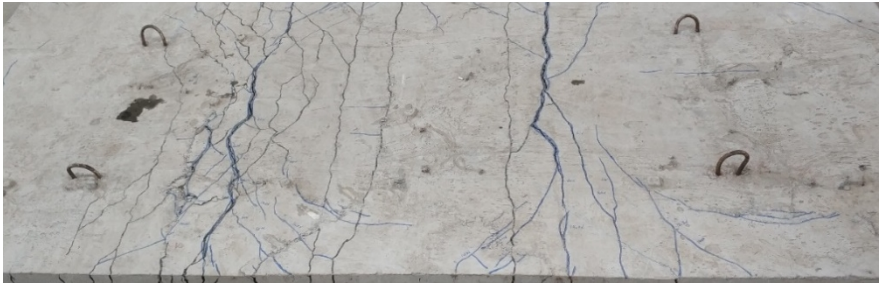
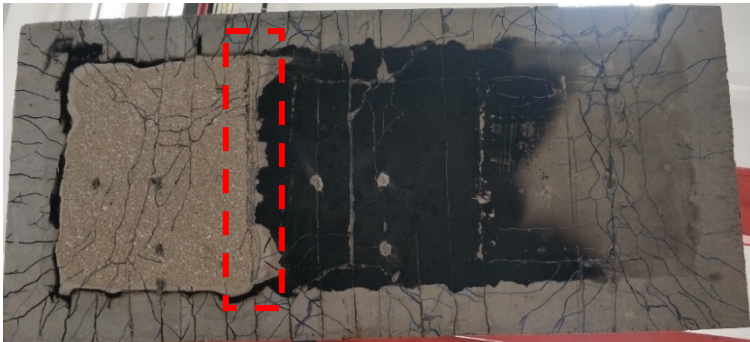
Fig.6. Failure modes of Slab S1-PF. (a) Cracks on the top surface; (b) Cracking pattern on the top surface; (c) Cracks on the bottom surface; (d) Cracking pattern on the bottom surface.

Figs. 5–10 show the cracking pattern on the top and bottom surfaces of each span in the six continuous slabs. For each fire-damaged slab, the blue and dark lines indicate new and original cracks, respectively.

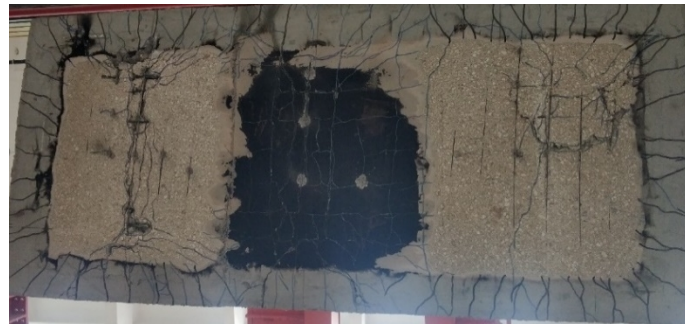
Fig.8. Failure modes of Slab S3-PF. (a) Cracks on the top surface; (b) Cracking pattern on the top surface; (c) Cracks on the bottom surface; (d) Cracking pattern on the bottom surface.

As shown in Figs. 7(a), 8(a), and 9(a), the punching cone pointed by the red circle was fully or partially developed over the thickness of the slab, including Span B in Slabs S2-PF and S4-PF, and Span C in Slabs S2-PF and S3-PF. The worst case was Span B in Slab S2-PF because the critical concrete failure appeared near to the internal support. In contrast, the punching perimeter location of other slabs was identical to the area of the steel plate (Fig. 2(c)); this was due to the high local stress. Meanwhile, apart from explosive spalling in Span B of Slab S2-PF, no bottom bars near the punching cone broke the concrete cover ripping out of the slab. This comparison indicates that the serious spalling had a critical effect on the punching failure mode, i.e. location and area of the punching cone.

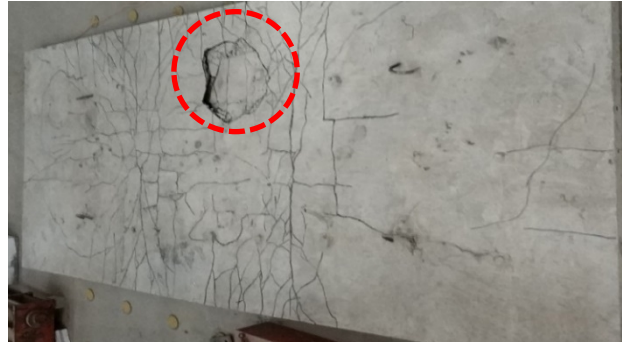
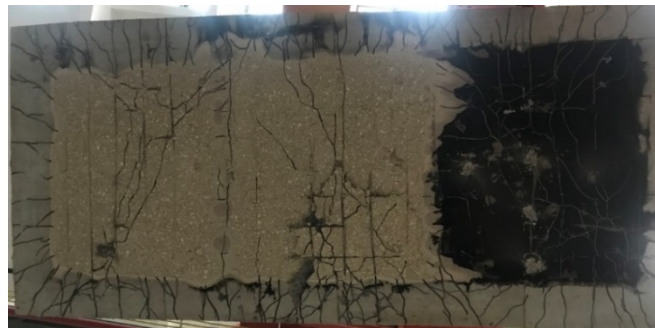
Fig.9. Failure modes of Slab S4-PF. (a) Cracks on the top surface; (b) Cracking pattern on the top surface; (c) Cracks on the bottom surface; (d) Cracking pattern on the bottom surface.

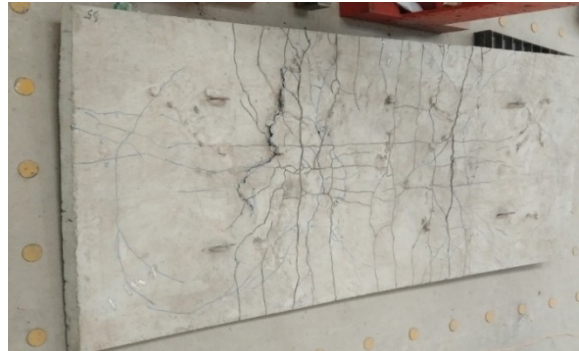
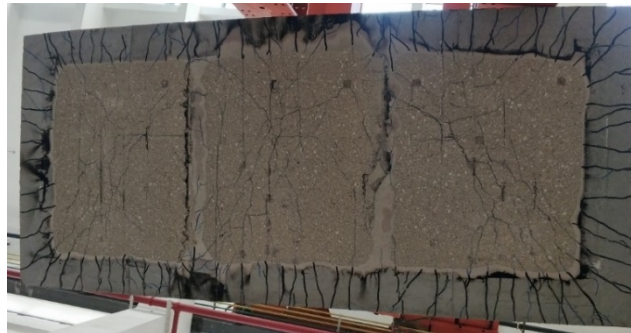
Fig.10. Failure modes of Slab S5-PF. (a) Cracks on the top surface; (b) Cracking pattern on the top surface; (c) Cracks on the bottom surface; (d) Cracking pattern on the bottom surface.
